PHASE II ENVIRONMENTAL SITE ASSESSMENT

**PRO LINE BOATS
1520 SOUTH SUNCOAST BOULEVARD
HOMOSASSA, FL 34448**

ENERCON PROJECT NO. RIMS 13-003623-03-4

December 2, 2014

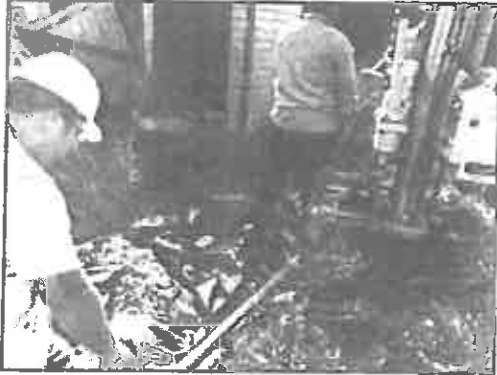
1 : Soil boring location of SB-1 and TMW-1 adjacent to catalyst shed.

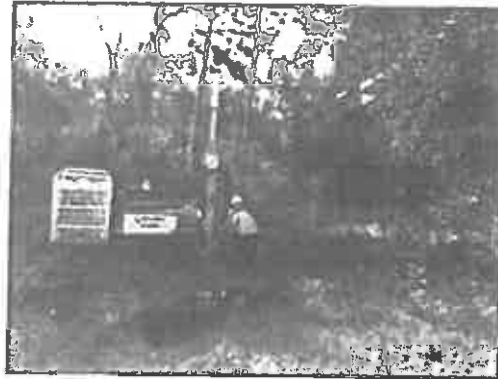
2 : Soil boring location of SB-2 and TMW-2 adjacent to east side of the septic leach field area.

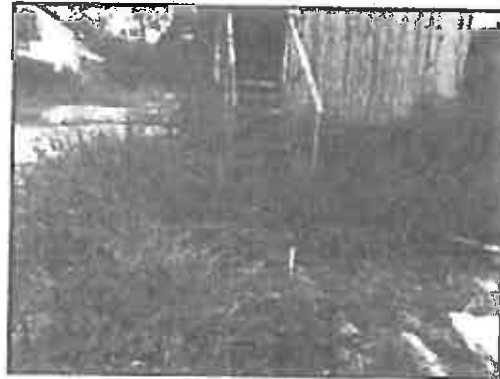
Soil boring SB-4 was advanced on the northern side of the former hazardous waste storage and resin tank located on the western portion of the subject property. The soil boring was extended to a total depth of ten bgs. No petroleum hydrocarbon odors were detected in this soil boring. Groundwater was measured in the soil boring at a depth of approximately 4.58 fbtoc. A soil sample (SB-4) was collected from approximately two feet bgs for laboratory analysis for VOC s via EPA Method 8260 and RCRA 8 metals via EPA Method 6010 and mercury via EPA Method 7471. The soil sample SB-4 COC concentrations of chromium, lead, acetone, barium, and mercury were detected above the laboratory MDL but were identified below their respective FDEP SCTLs. All remaining constituent concentrations were below their respective FDEP SCTL.

4 : Soil boring SB-4 and TMW-3 location on the northern side of the resin tank.

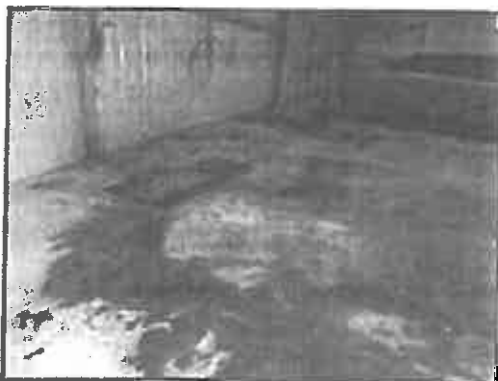
Soil boring SB-5 was advanced within the vicinity of the pressure powered resin/catalyst application equipment, observed within the southern interior portion of the subject building, which was located on the southwestern corner of the subject property. Significant staining was observed to the concrete slab surrounding the equipment. The soil boring was extended to a total depth of ten bgs. No petroleum hydrocarbon odors were detected in this soil boring. Groundwater was measured in the soil boring at a depth of approximately 5.37 fbtoc. A soil sample (SB-5) was collected from approximately two feet bgs for laboratory analysis for VOC s via EPA Method 8260 and RCRA 8 metals via EPA Method 6010 and mercury via EPA Method 7471. The soil sample SB-5 COC concentrations of chromium, lead, acetone, and barium were detected above the laboratory MDL but were identified below their respective FDEP SCTLs. All remaining constituent concentrations were below their respective FDEP SCTL.

5 : Soil boring SB-5 and TMW-4 location on the southern interior portion of the subject building.

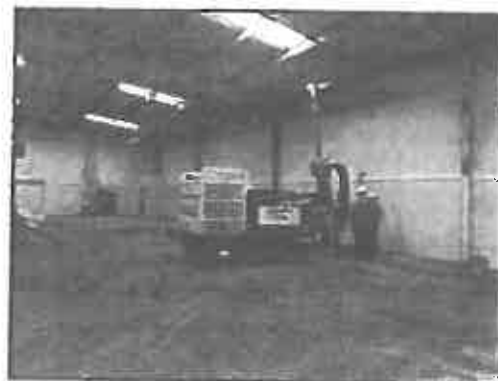
equipment, observed within the northern interior portion of the subject building, which was located on the southwestern corner of the subject property. Significant staining was observed to the concrete slab surrounding the equipment. The soil boring was extended to a total depth of ten bgs. No petroleum hydrocarbon odors were detected in this soil boring. Groundwater was measured in the soil boring at a depth of approximately 5.26 fbtoc. A soil sample (SB-6) was collected from approximately two feet bgs for laboratory analysis for VOCs via EPA Method 8260 and RCRA 8 metals via EPA Method 6010 and mercury via EPA Method 7471. The soil sample SB-5 COC concentrations of chromium, lead, acetone, barium, and mercury were detected above the laboratory MDL but were identified below their respective FDEP SCTLs. All remaining constituent concentrations were below their respective FDEP SCTL.

6 : Soil boring SB-6 and TMW-5 location on the northern interior portion of the subject building.

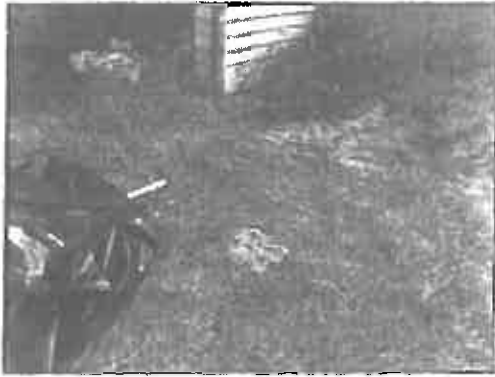
7 : Soil boring location SB-1 abandoned.

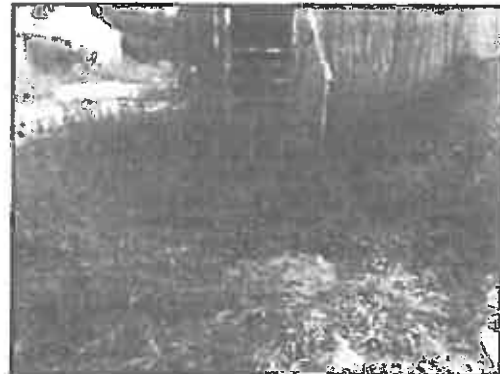
10 : Soil boring location SB-4 abandoned.

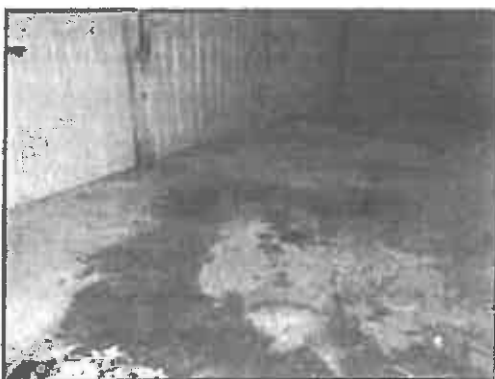
11 : Soil boring location SB-5 abandoned.

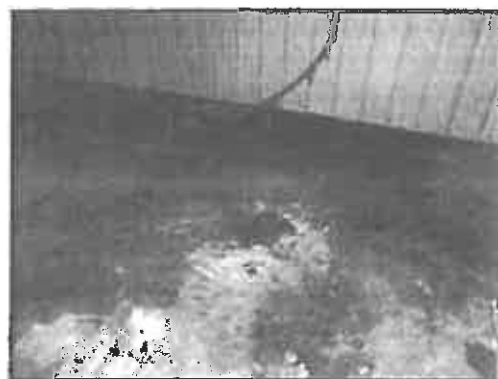
12 : Soil boring location SB-6 abandoned.
